Dolby Laboratories Inc

Field Bulletin 200

Model CP500 Random Clicking Noises or High Hiss Level Cat. No. 681 Digital Audio Clock Circuit

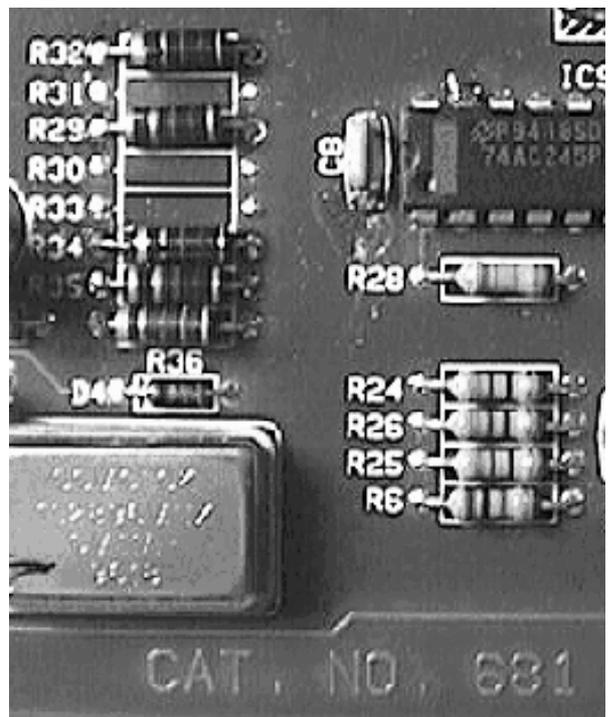
2. Looking at the board with the component side towards you and the connector on the left, find the small metal can at the lower left corner. Directly above this is a column of five resistors. The components to be replaced are designated R32, R29, R34, R35, and R36. Note that there are three empty component positions (R30, R31, and R33). This is intentional and these positions should remain empty.

De-solder and remove each resistor and replace it with a 0.15 microhenry inductor (Dolby Part Number 14086 available at no charge from Dolby offices). The inductors will fit correctly in the spaces vacated by the resistors.
