Dolby Laboratories Inc

Field Bulletin 220

Model CP500 Cinema Processor

Intermittent Cat. No. 675A Failure

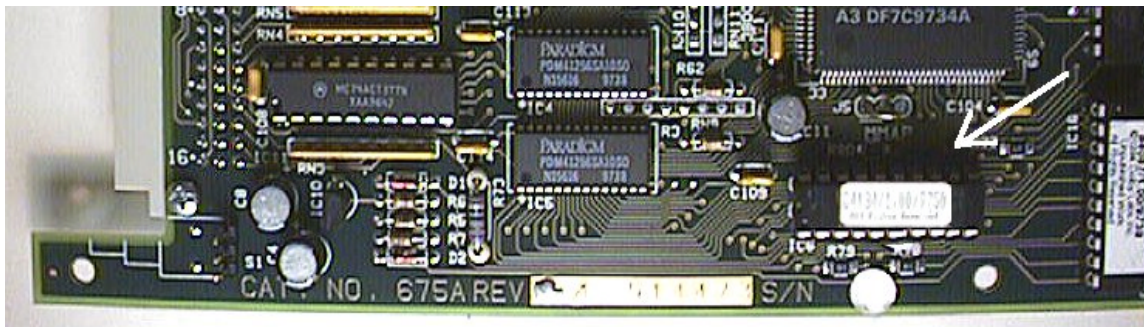
A number of Cat. No. 675A boards manufactured recently have been returned to us because of intermittent failure. Our investigation has pointed to a potential problem with one particular Gate Array Logic (GAL) part used on the board as the part becomes too slow to allow reliable operation at high operating temperatures.

On Cat. No. 675A boards which show any of the Symptoms listed above and with a serial number between 11500 and 16700, the GAL in location IC6 needs to be replaced. This part is located close to the serial number on the bottom edge of the board and can be identified by the label showing the number 84135/1.00/yyww (see below) where yyww indicates the year and week of manufacture of the part.

IC6 is a socketed part and can easily be changed in the field. Replacement ICs should be requested from Dolby Laboratories and the original ICs should be returned to Dolby Laboratories.
