Dolby Laboratories Inc

Field Bulletin 226

No Sound After Reversion from Digital to Analog DA20 with Model SA10 Installed

Issue 1
S99/12648
July 12, 1999

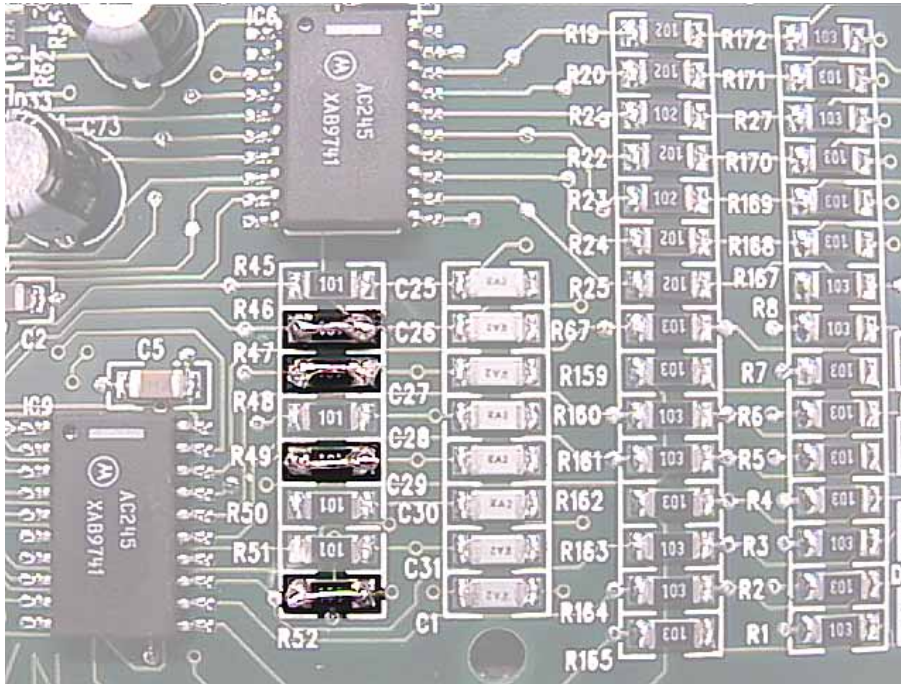
Resistors located on the Cat. No. 611A prevent the reversion command generated by the DA20 from being accepted by the CP65/55. The CP65/55 will not switch to format 05 (SR).

4. Find the short column of surface-mount resistors located toward the bottom of the card as shown in the photograph.

5. Using a low-wattage soldering iron (35W or less) and a very thin piece of wire, short resistors **R46, R47, R49 and R52**. Link across the body of each resistor. If you use too much heat, the resistor may inadvertently unsolder. If this happens, carefully use the same thin wire to jumper the remaining two solder pads on the board.
