Dolby Laboratories Inc

Field Bulletin 227

CP500 Loss of Sound During Power-Up Cat. No. 675A or Cat. No. 662A

S99/12648
February 2000

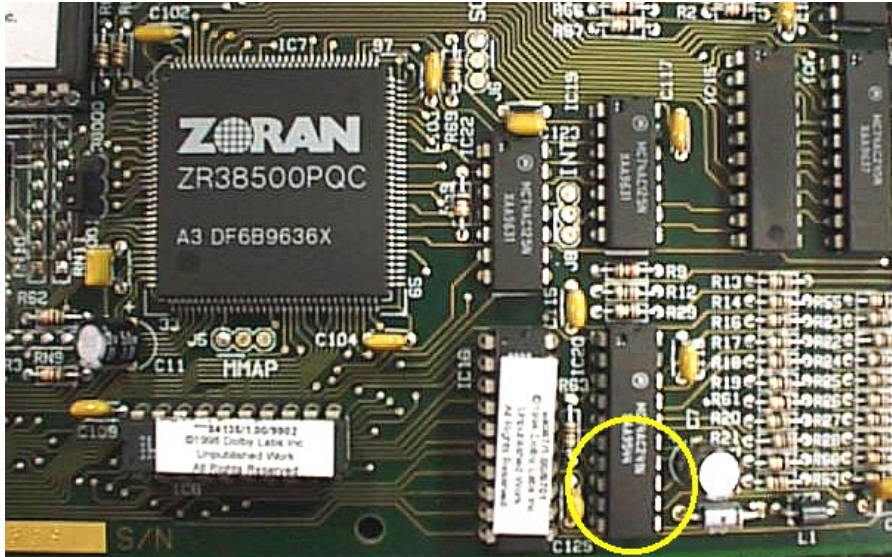
One or more of the Digital-to-Analogue Converter ICs on the Cat. No. 662A are not initialising correctly and are therefore unable to decode the digital audio signal being sent to them. There are two possible reasons for this same fault occurring in the CP500. The first is due to noise on two clock lines on the Cat. No. 675A during the power-up cycle. The second is due to internal changes within the Digital to Analogue converter IC on the Cat. No. 662A.

Using the photograph below as a reference locate IC20 on the Cat. No. 675A board.

1. Remove the Cat. No. 675A board in slot J14 and add a resistor to ground on each of the two noisy clock lines.

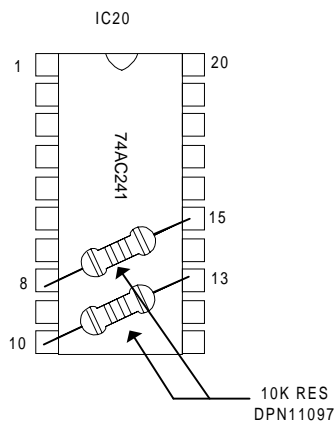
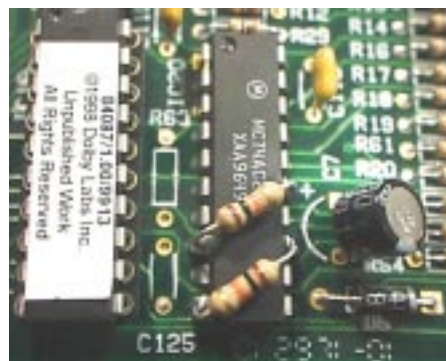
Note: R63 and C125 to the left of IC20 may or may not be installed depending upon the age of the board.

Carefully solder one 10k ohm 5% 0.25W resistor between pins 13 and 10 of IC20 and another 10k ohm 5% 0.25W resistor between pins 15 and 8 as shown on the drawing and photograph below.

Replace the Cat. No. 675A in slot J14.

If after adding the two resistors to the Cat. No. 675A the problem of loss of channels on power-up still exists, check the revision of the D-to-A converters on the Cat. No. 662A as described in section 2 below.

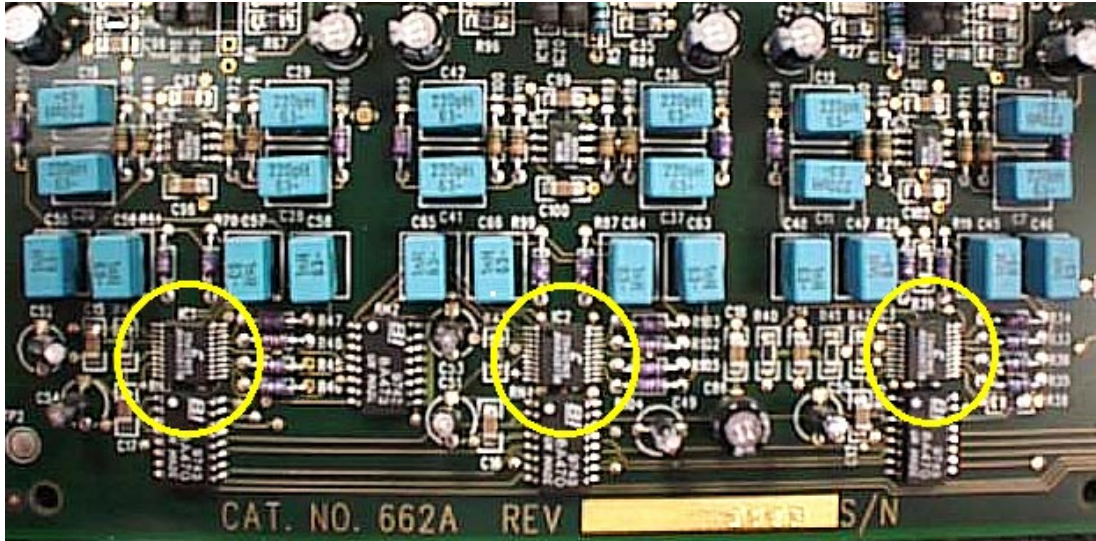
2. Remove the Cat. No. 662A board from slot J11. Using the photograph below as a reference locate the D-to-A converters IC1, IC2 and IC3.

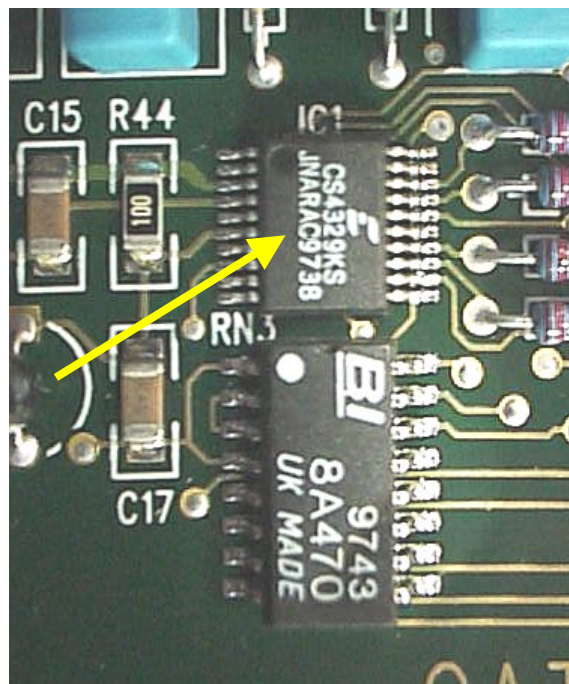
Check the marking on each of the three ICs to determine the manufacturer's revision code.

The revision code is included on the second line of text on the body of the IC and is the last letter in the sequence before the numbered date code. The example above shows revision code "C" in the line JNARACC9738.

If any of the ICs show revision code C, contact Dolby Laboratories for a replacement Cat. No. 662A card.
