DATE Dec. 1981
NUMBER 90-23 -A

SERVICE BULLETIN

INDEX PREVENTIVE MAINTENANCE (REVISED)

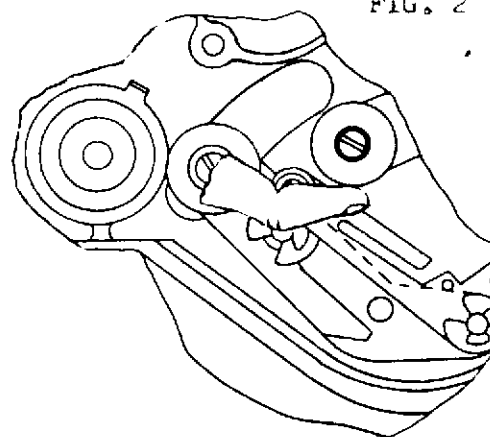
FIG. 2

B. Gate Lever operation.

PROBLEM: Improper operation of Gate Lever will not set the required loops causing projector to shut off upon turning the Control Knob.

REMEDY: Raise Gate Lever to full open position. Lower Gate Lever slowly until rear shoe closes. Check lower loop setter to see if it can be released very easily by lifting it with finger. (Refer to Fig. 2). It should be firmly in position. If it releases by applying a slight pressure, press lever (A) Fig. 3 in towards casting slightly so that lever will be seated properly on catch (B). Continue to lower Gate Lever slowly until lower loop releases then press on top loop setter to be sure it is securely seated.

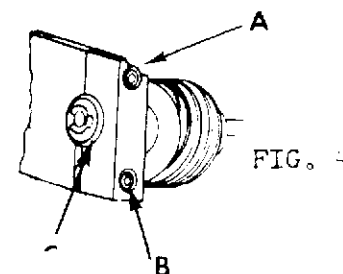
FIG. 4

C. Bearing at end of Oscillator Shaft.

PROBLEM: Loose bearing will cause excessive shuttle protrusion.

CAUTION: Excessive tightening will cause the mechanism to bind and run unevenly.

REMEDY: Tighten top screw (A) securely. Tighten screw (B) just tight enough so that the bearing will not move. Do not overtighten. The best method to check this is to insert shuttle adjustment wrench at point (C), and with excessive pressure the bearing should not move. If it does, tighten Screw (B) until the bearing doesn't move. (Refer to Fig. 4)

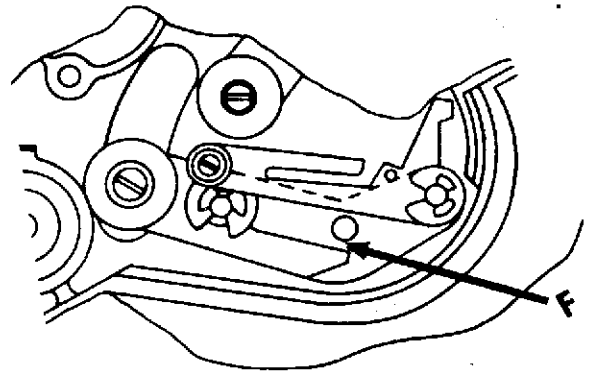
FIG. 5

D. Check Pinch Roll pressure.
PROBLEM: Garbled sound.

1. Rotate Control Knob to Forward operating position. There should be approximately 1/8" clearance between Pinch Roller Arm Assembly and stud on Pinch Roller Actuating arm. (Refer to Fig. 5)
2. If you do not have this clearance, perform the following:
 - A) If serial number of projector is below 920-6587, replace Cam Bearing Assembly behind Control Knob. (Refer to Fig. 6)
 - B) To adjust, loosen screw (A) Fig. 7. Rotate excentric (B) counterclockwise approximately 1/4 turn. Secure screw (A).
 - C) Control Knob may be loose. Tighten. There should be a slight amount of forward motion of Control Knob after knob is in Forward position. If not, remove knob and file about 1/4 off of extrusion on knob. (Refer to Fig. 8)

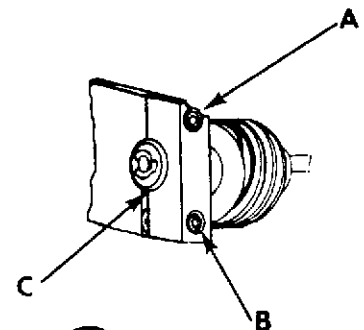
FIG. 9

E. Check Shuttle Protrusion

PROBLEM: Excessive or insufficient shuttle protrusion will cause continual revolving of lower loop setter.

- REMEDY:
1. Loosen set screws (A) and (B) Fig. 9.
 2. Rotate hex end of bearing at point (C) clockwise to decrease protrusion; counterclockwise to increase protrusion. (Use shuttle wrench 53529)

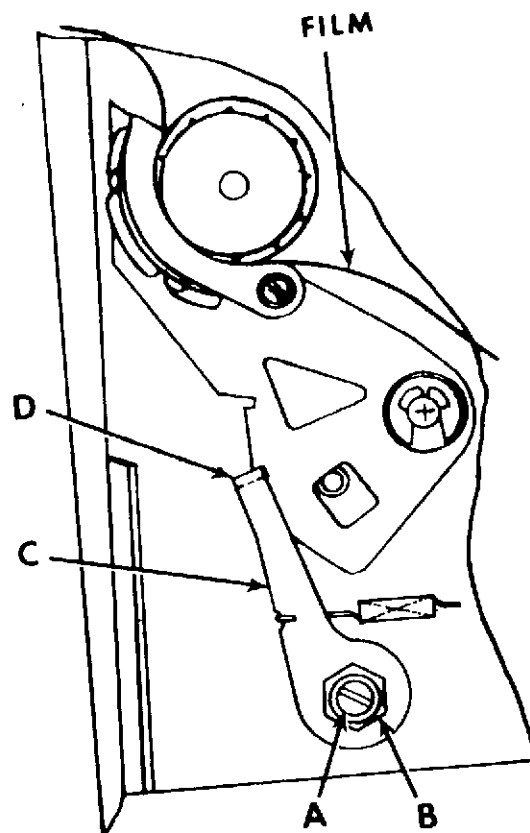
FIG. 12

F. Rear Shoe

PROBLEM: Film slipping through Rear Shoe causing Top Loop Setter Switch to activate turning off projector.

- REMEDY:**
1. Thread projector and close gate.
 2. Loosen screw (A).
 3. Rotate excentric (B) clock-wise which will raise latching lever (C).
 4. Latching lever (C) should just touch top on notch on shoe bracket at point (D) and then tighten screw (A) securely.
 5. Raise Gate Lever to full open position.
 6. Rotate Control Knob to Forward position and while projector is running film, manually move latch lever to left and then release. It should just clear top of notch at point (D) without binding.

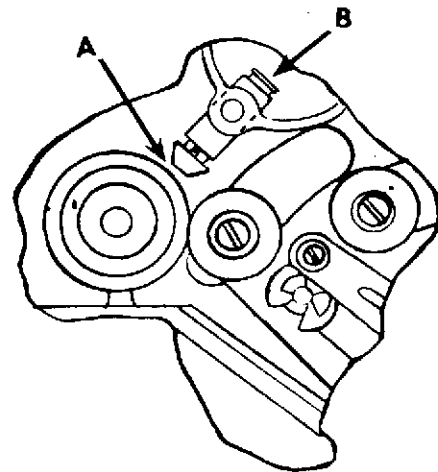
FIG. 16

I. Sound Lens Assembly

PROBLEM: Muffled sound. Low volume.

REMEDY: Remove foreign material from Sound Lens using a pipe cleaner dipped in alcohol. Insert the pipe cleaner between the Sound Drum and the Sound Lens at Point A. Clean the glass disc covering the top of the Sound Lens, Point B.

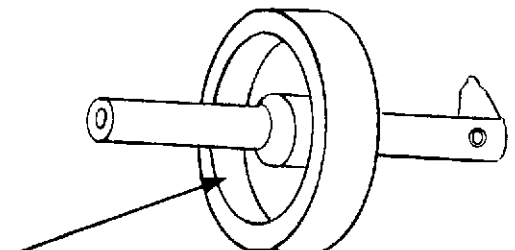
FIG. 17

J. Lubrication of Take-up Spindle

PROBLEM: Excessive tork on take-up.

REMEDY: Remove spindle from Take-up Arm. Apply special lubrication S111-13 on cork. Refer to Fig. 17. (note: we began using this new lubrication on projector serial No. 921-4358)

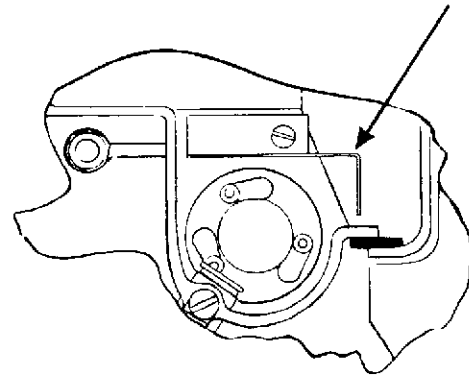
FIG. 19

K. Lamp Replacement Designation

PROBLEM: Incorrect exciter lamp causing low volume.

REMEDY: Place on the exciter lamp shield the self-adhesive sticker #53925. Refer to Figs. 18 & 19.

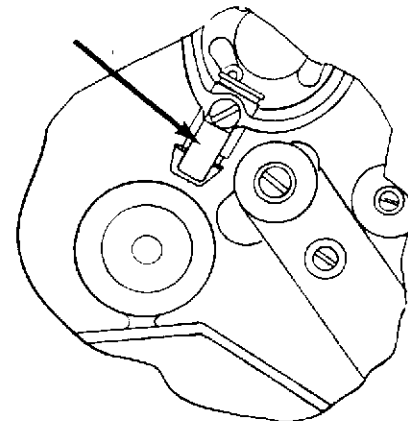
FIG. 20

L. Sound Lens Film Guide

PROBLEM: Film lays against sound lens causing no sound.

REMEDY: Install Film Guide #53924 using screw #S254-832-3. Refer to Fig. 20. (note: we began installing this film guide with projector serial No. 921-3819)

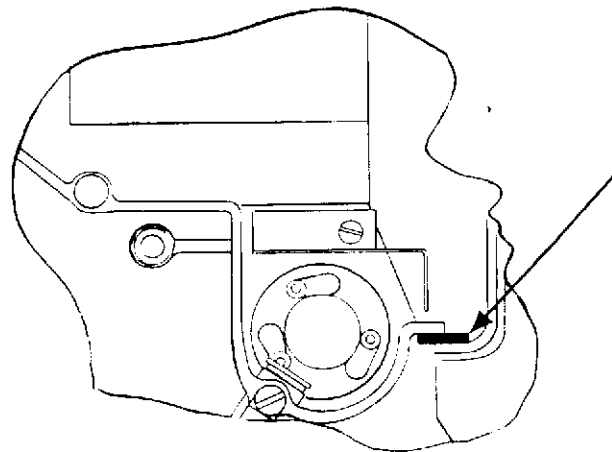
FIG. 21

M. Oil Seepage onto Sound Lens.

PROBLEM: Muffled and low volume.

REMEDY: Place a strip of felt onto casting as illustrated in Fig. 21. (note: this began with projector serial No. 921-4105)
#54172 Felt Strip
