Dolby Laboratories Inc

Field Bulletin 185

Cat. No. 249A Modification To Increase Immunity To Going Into Bypass

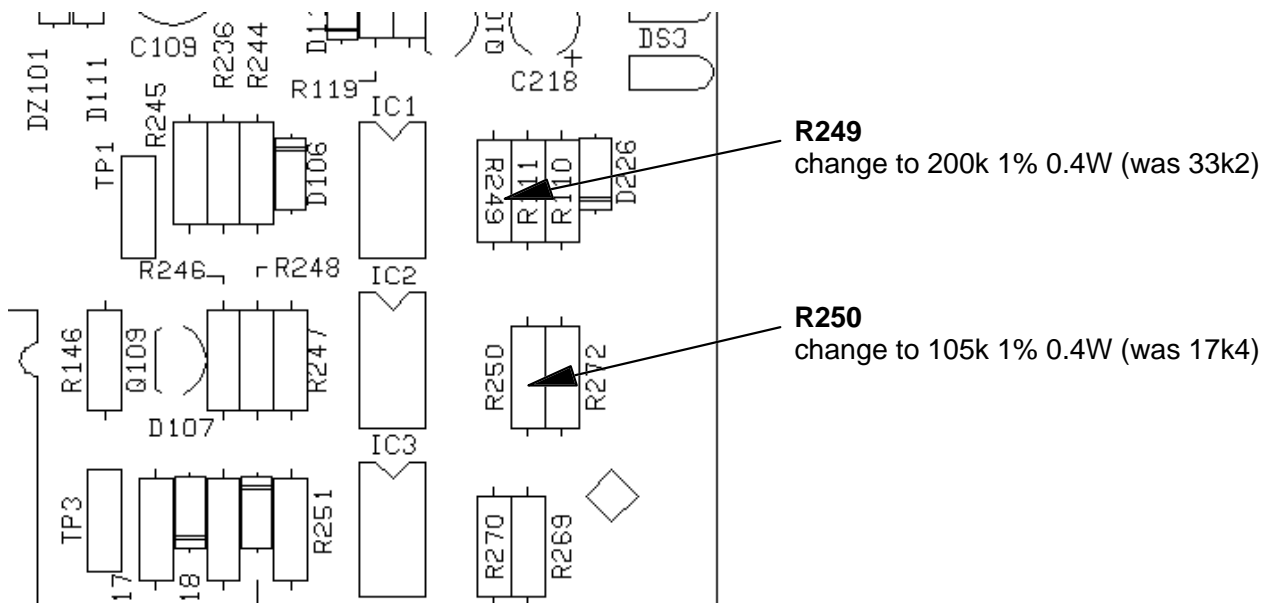
Fault Symptom: Model CP65 goes into Bypass mode, caused by interference, for example from Xenon lamps.

Reason: The op-amp IC1b on the Cat.No.249A, type LM358, may latch up (some manufacturers' components only).

figure 1 - Cat.No.249A PCB - resistor changes

Modification: Change two resistor values R249 and R250. See Figure 1. The change to eliminate this potential problem was incorporated into all units manufactured after August 1995 with the introduction of Cat.No.249A Rev 6. All earlier revisions of Cat.No.249A may require modification - the revision number of the PCB can be found on the lower edge of the solder side of the PCB.
