Dolby Laboratories Inc

Field Bulletin 222

CP65 with DA20

Incorrect Wake-up Format after Power-up

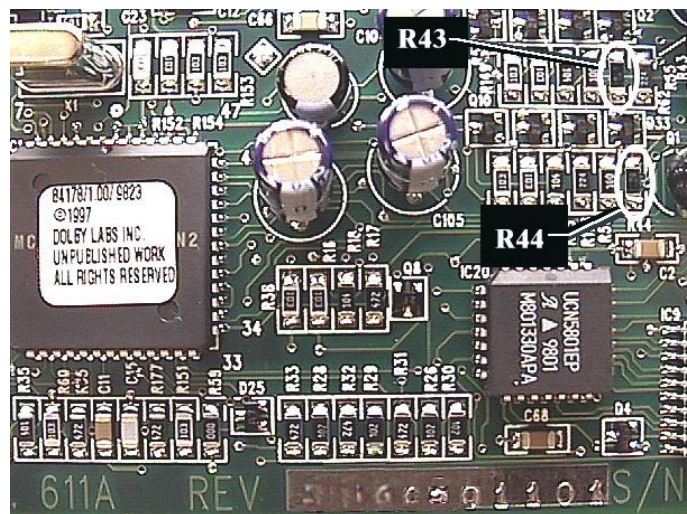
1. Shut off the power to the DA20.
2. Remove the 12 front panel mounting screws.
3. Remove the Cat. No. 611A card from the last right-hand slot.
4. Referring to the figures below, locate resistors R43 and R44.

- Using a small sharp-pointed cutter located at the center portion of the resistor body, shatter each resistor. The resistors should break away cleanly and leave no connections. **Use care to prevent the cutter's sharp tips from damaging any traces on the board beneath the resistors.**

Do not use a soldering iron. A hot soldering iron can damage the surrounding surface-mounted components or PC board traces.
