The two most common complaints about reverse scan analog and Dolby digital basement readers associated with Simplex 5 Star soundheads.

1. Dolby Digital looks fine on O' scope but error rate reads 8, F, 8, F,
2. Reverse scan analog reader won't stay in lateral alignment

Following are some helpful hints on how to troubleshoot these problems

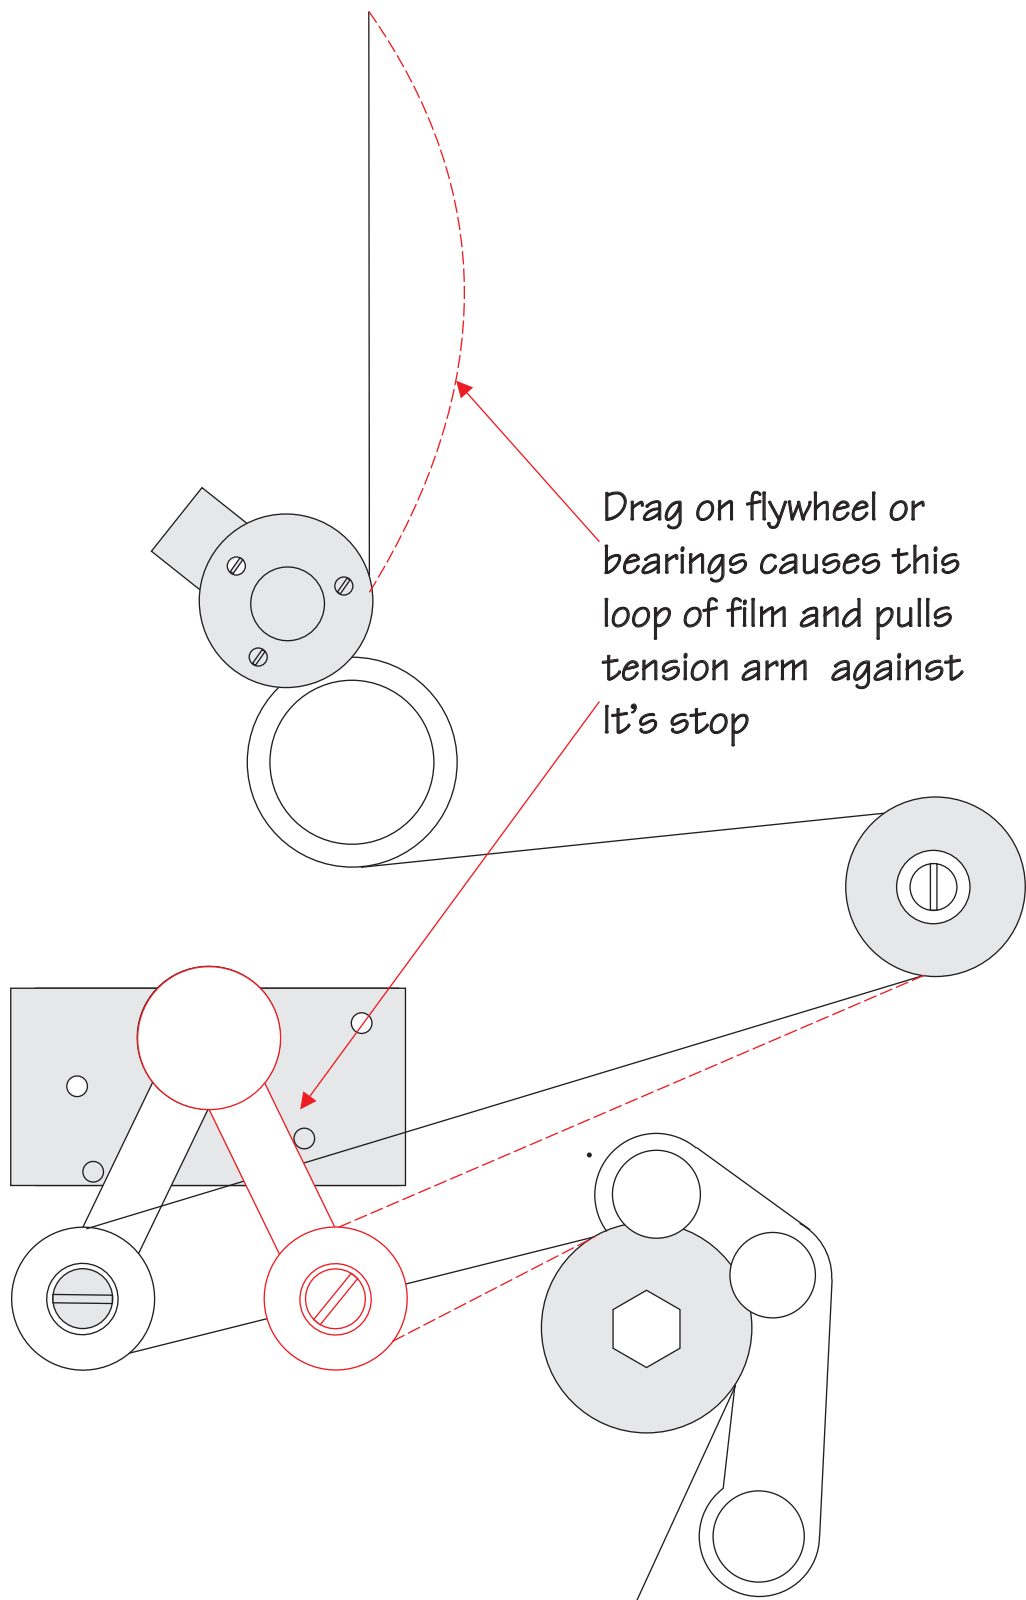
Figure #1

Figure 1 shows the result of defective bearings and/or drag on the flywheel from the cover or wiring touching the flywheel. Either will cause wow and flutter in the analog system and high vertical jitter in the digital system.

Drag on flywheel or bearings causes this loop of film and pulls tension arm against its stop

DO NOT USE SEALED BEARINGS they have too much drag. Replace the bearings as necessary with 6202 ZZ shielded bearings. Insure also that the spring washer under the rear bearing is properly installed. Re route wiring if necessary under the back cover. Sometimes the rear cover itself must be held away from the flywheel when you tighten the screws that attach it. The scanning drum assembly should spin freely for 15 seconds or so after tail out.

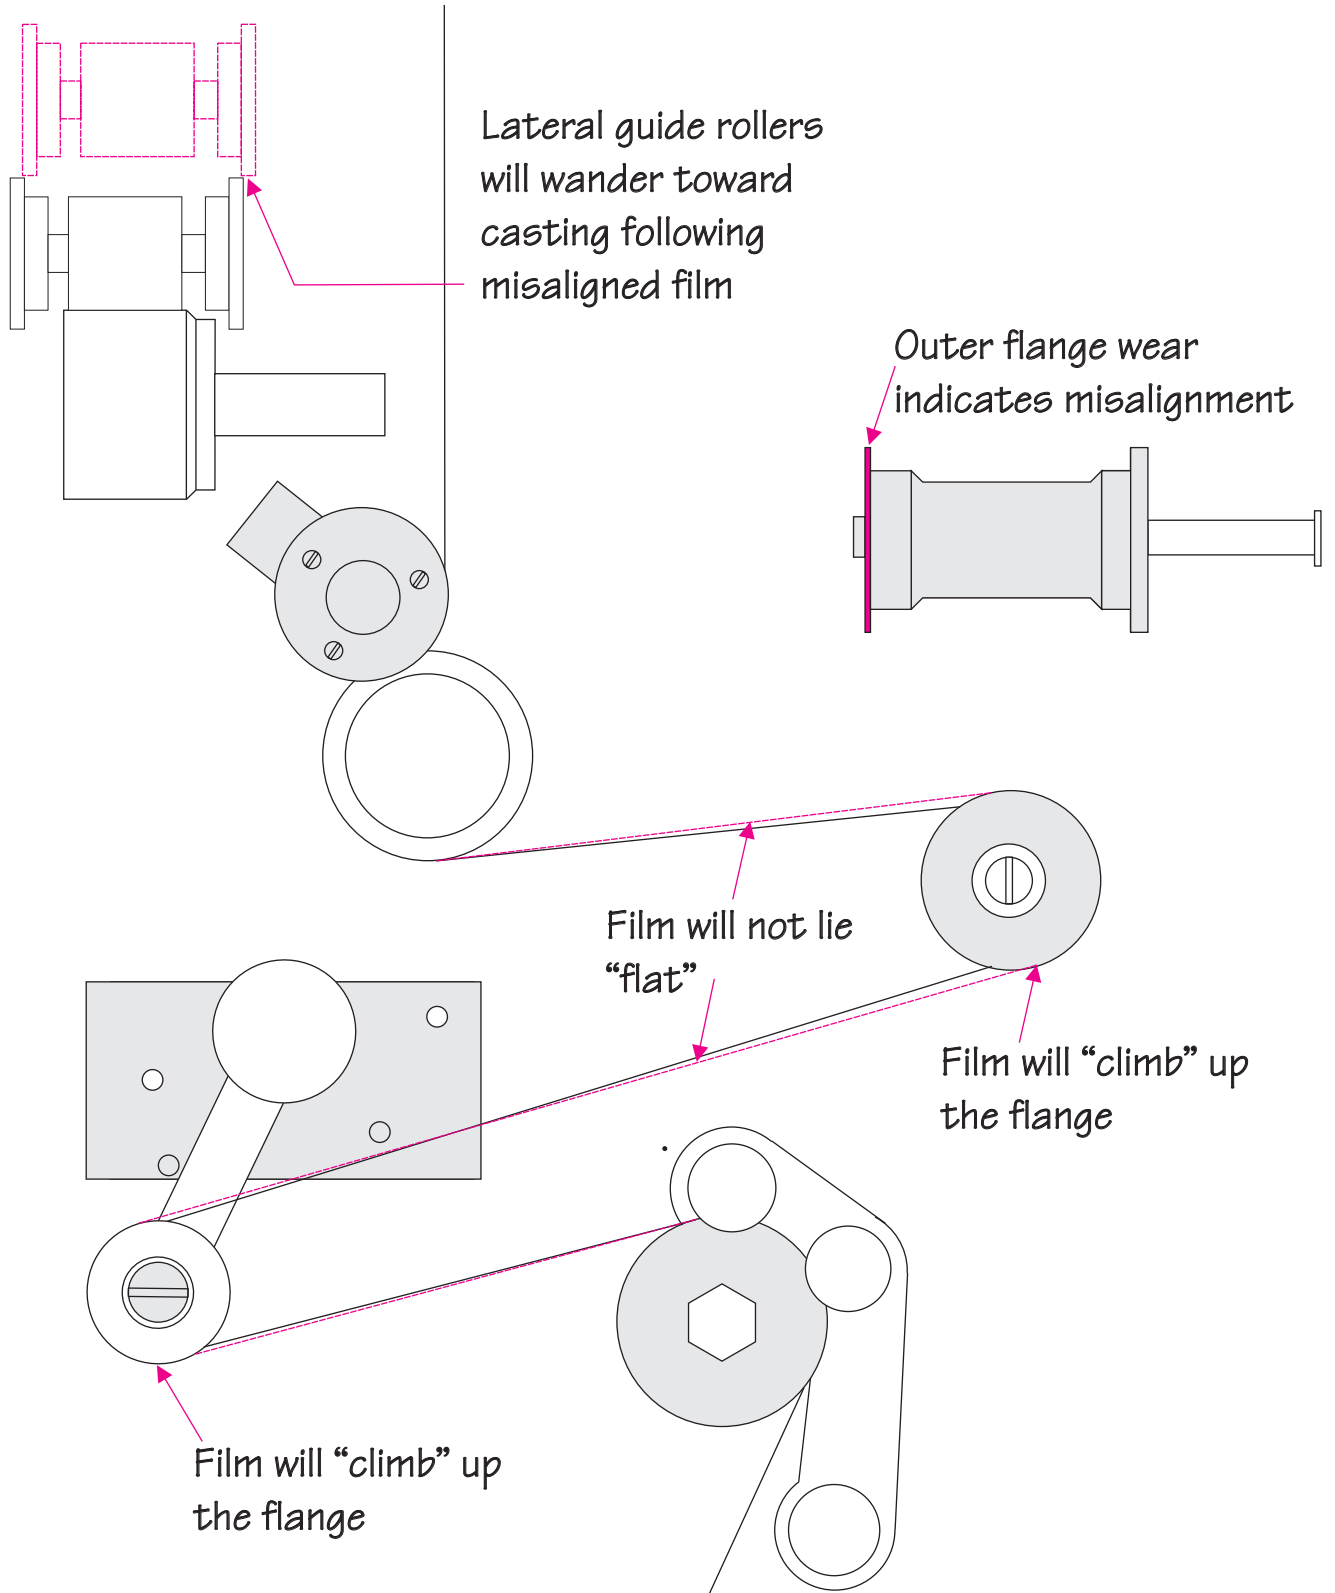
Figure #2

Figure 2 shows the result of misalignment of the rollers in the soundhead that cause analog tracking problems and lateral misalignment to the digital reader.

The film path symptoms are,

1. Wear on the outer flange of the idler roller
2. The film will not lie "flat" between the idler or the tensioning roller.
3. The film will "climb" up the flange and then fall back into the roller.
4. The lateral guide will "wander" inboard.

To expose this condition, thread up buzz track or Cat. 97, and adjust the lateral guide. With the loop still threaded, turn the projector on and off a few times letting it stop completely in between. Recheck the lateral guide adjustment. If adjustment has changed it is likely that the lateral guide is wandering.

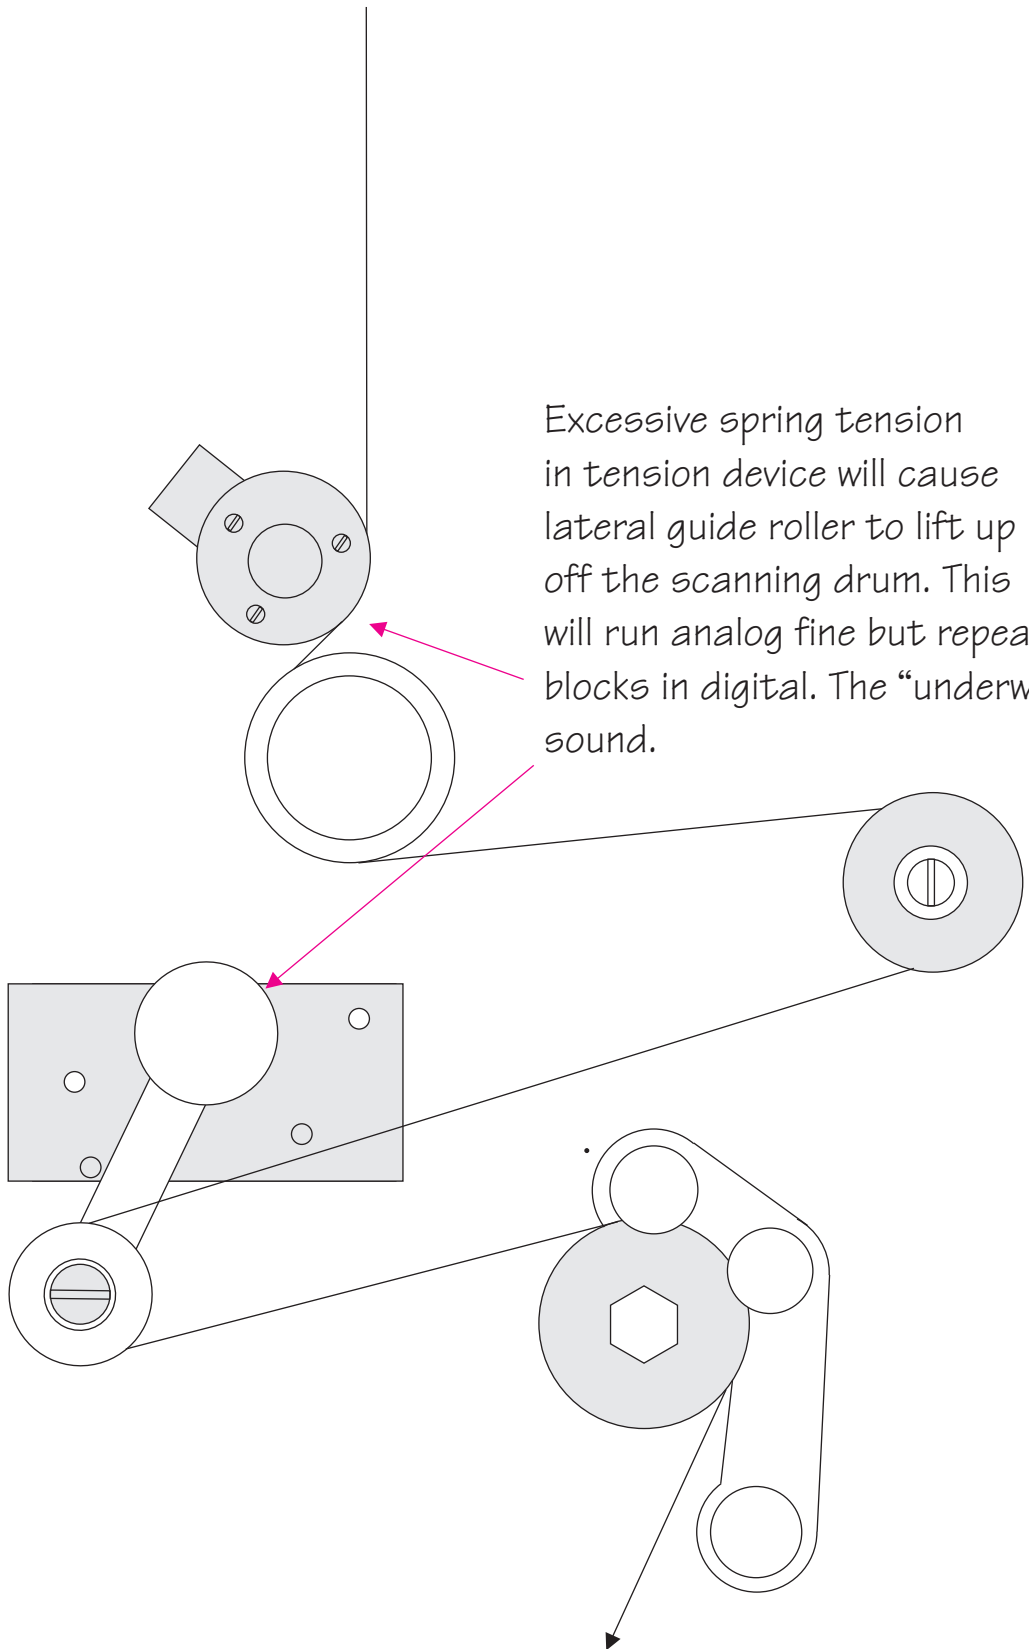
Figure #3

Figure 3 shows what happens when the spring tension in the tension device is too high.

Excessive spring tension in tension device will cause lateral guide roller to lift up off the scanning drum. This will run analog fine but repeat blocks in digital. The “underwater” sound.

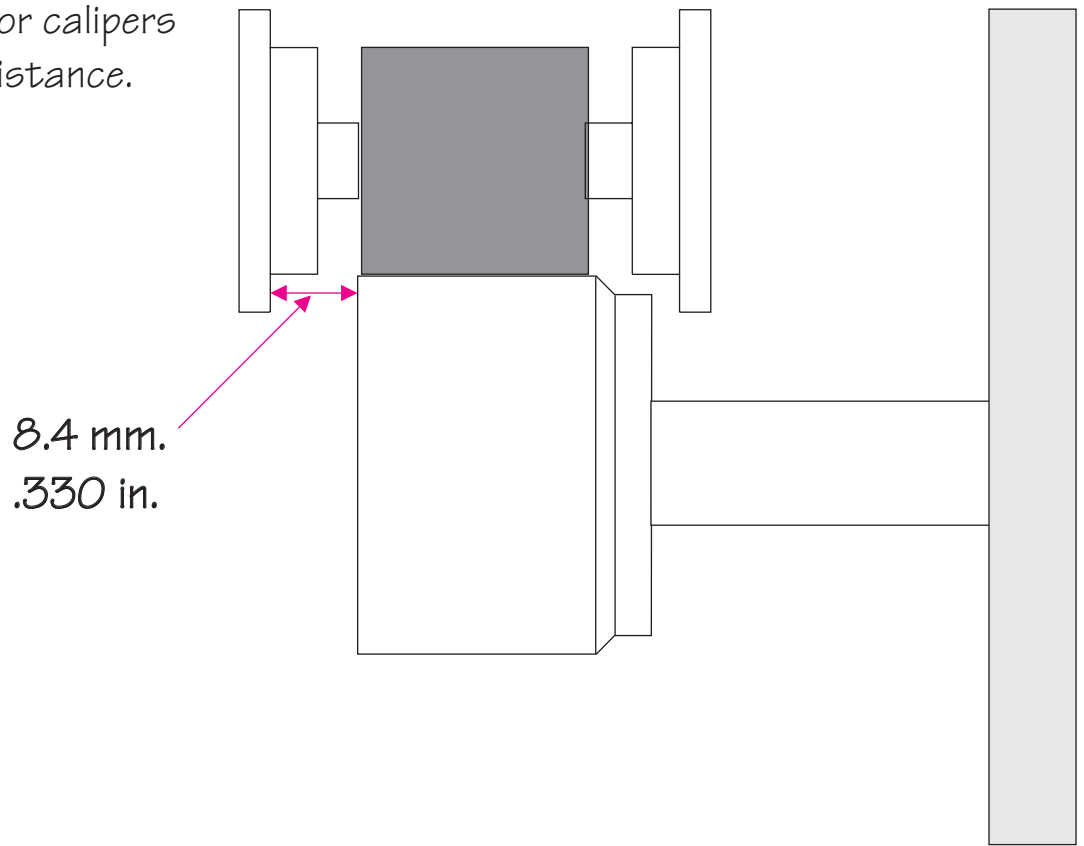
Figure #4

Figure 4 shows the proper distance between the scanning drum and the lateral guide.

Use a gauge or calipers to set this distance.

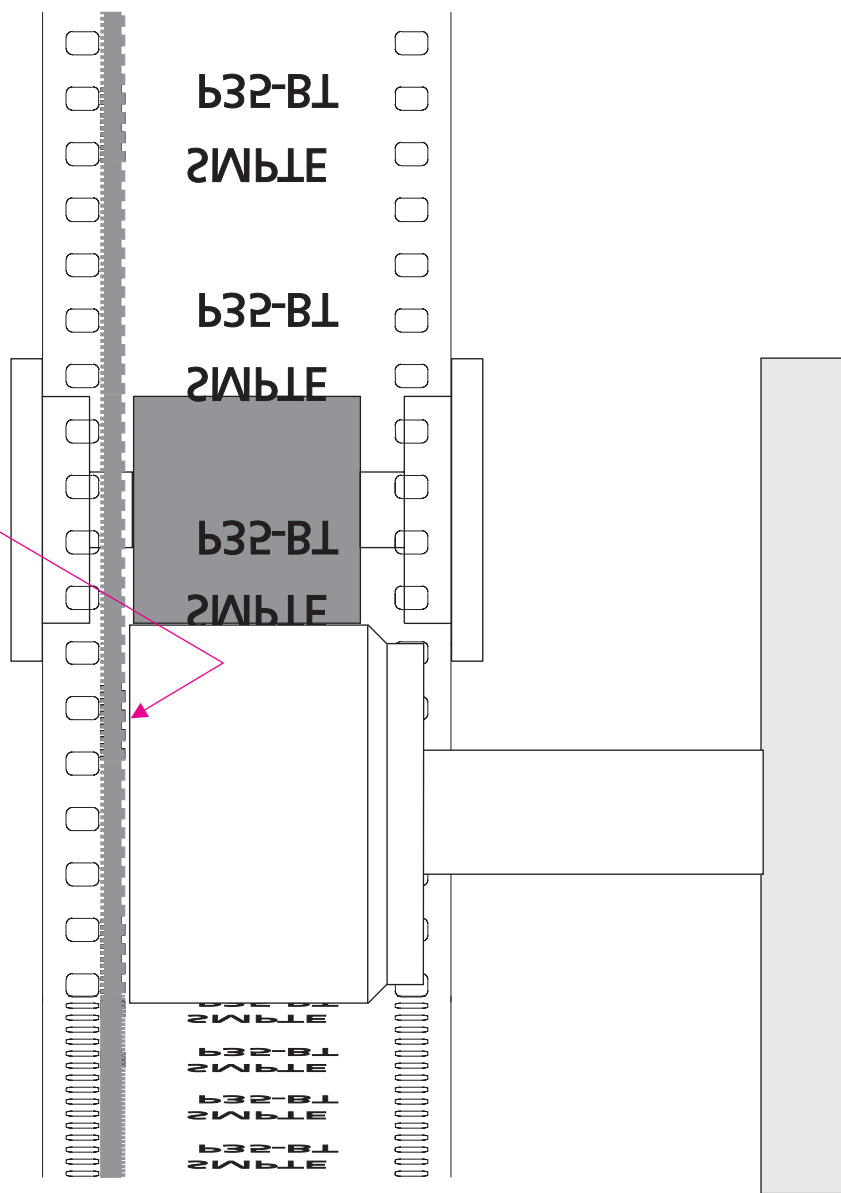
Figure #5

Figure 5 shows how to set the lateral guide in the absence of a gauge or calipers.

The large teeth of the Buzz track will be completely visible out over the edge of the scanning drum

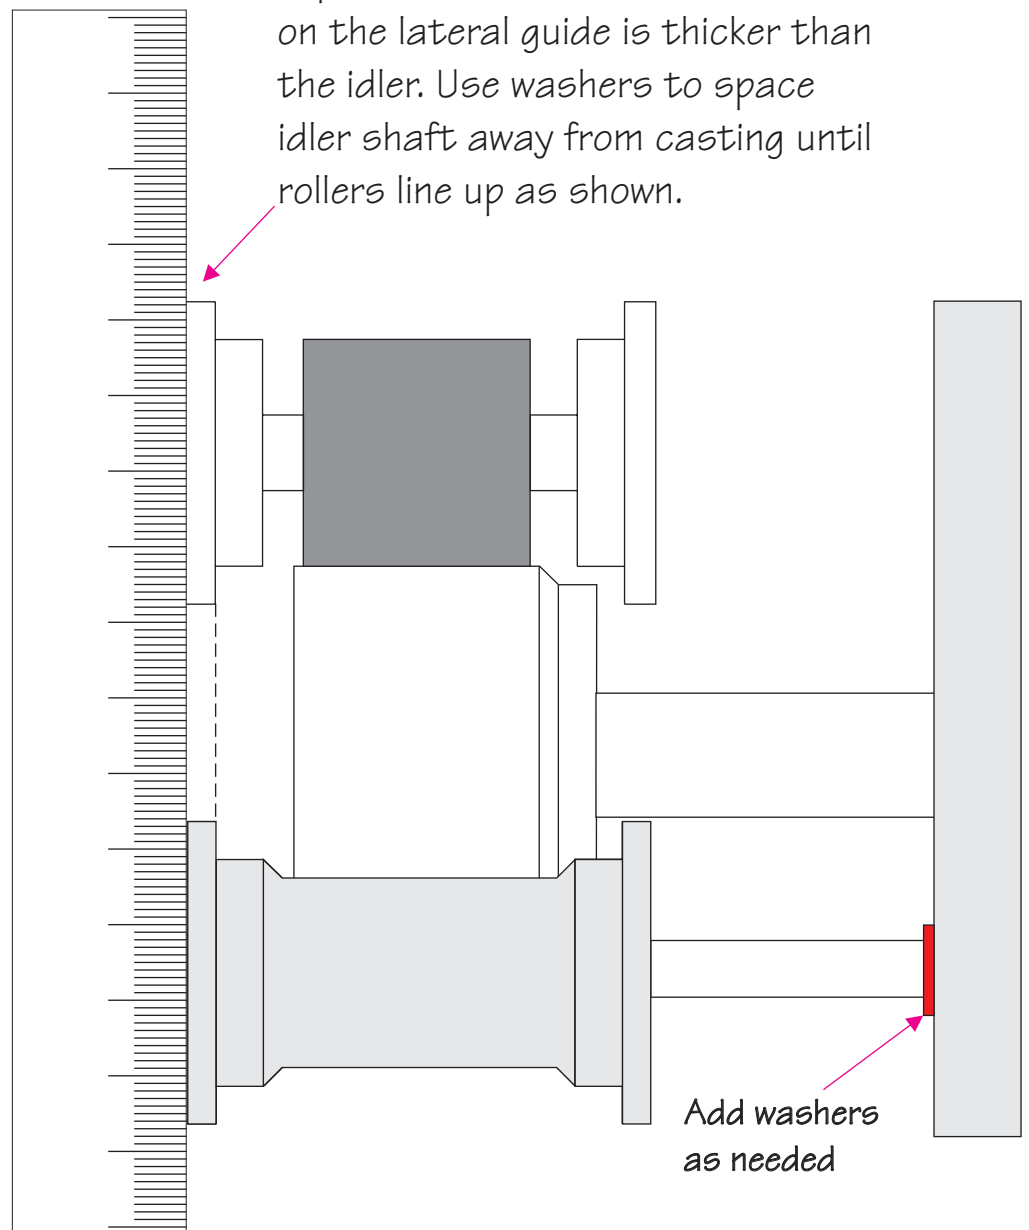
Figure #6

Figure 6 show how to align the idler roller to the properly aligned lateral guide.

Hold a steel ruler flat against the outside of the idler roller. Lay it on top of the lateral guide. The flange on the lateral guide is thicker than the idler. Use washers to space idler shaft away from casting until rollers line up as shown.
